## Frost resistance of natural stones – a case study from Finland

## Geotechnical report 13

Frost resistance of natural stones – a case study from Finland

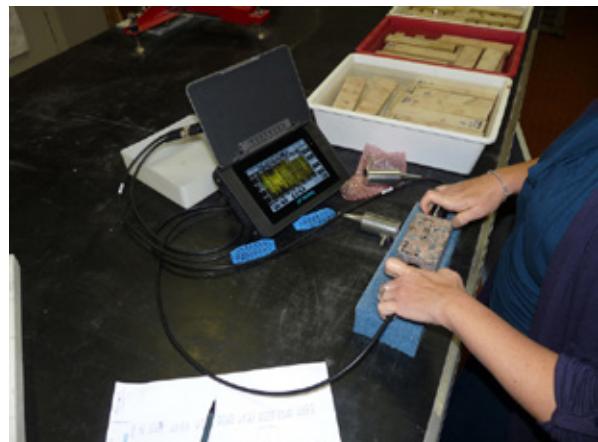
**Figure 4.** Ultrasonic pulse velocity (UPV) testing. Photo: Rossana Bellopede.

fresh material and on the same samples after 56 cycles of frost salt (Fig. 4).

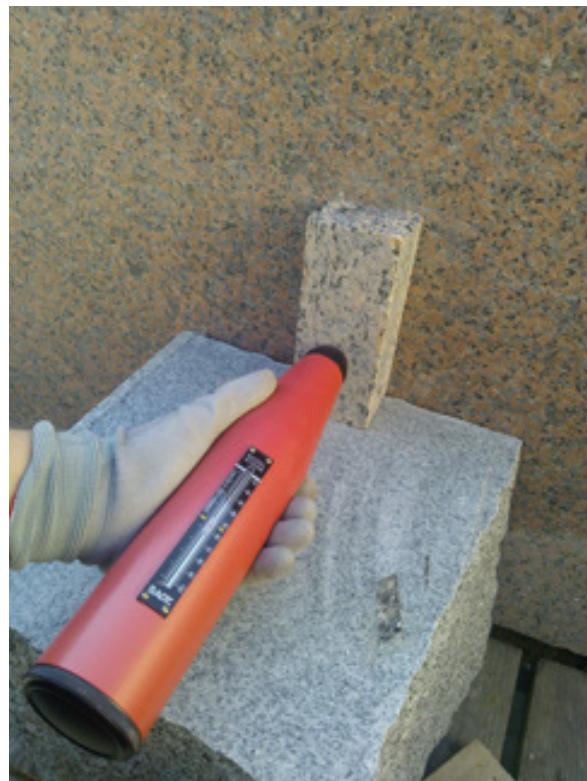
**Figure 5.** Schmidt rebound hammer instrument in testing position. Photo: Nike Luodes.

Schmidt rebound hammer (Fig. 5) test can be used to evaluate the weathering state of rocks in

Schmidt hammer tests were performed using a SADT Model HT225A hammer, performing three set of measurements of a chosen sample from the fresh and weathered material. Each set of measurement were composed by five horizontal rebounds per point, evaluating the average on the sample. The aim was to assess the surface weathering, also possible surface cracks, chipping, or rusting of the minerals. The test were performed keeping the instrument perpendicular to the vertically placed material (Fig. 5), as it had been used in previous site investigations on building walls by Luodes et al. (2014).

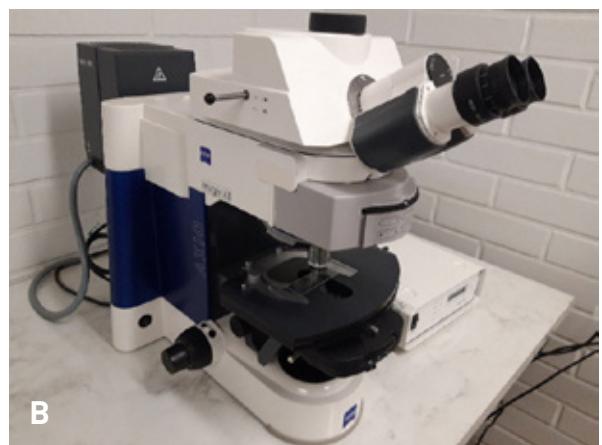
**Figure 6.** A. Analysis at the Scanning Electron Microscope (SEM). Photo: Nike Luodes. B. Optical fluorescent microscope. Photo: Akseli Torppa. Equipments in the GTK Mintec unit in Outokumpu.

*Scanning electron microscope* (SEM) was used in some cases to measure the dimension of the cracks (Fig. 6A), but the picture of the material got did not allow to distinguish open and accessible cracks from closed ones. In this case, the section of 15 mm x 25.5 mm was divided into five vertical sections and 17 horizontal measuring lines, and a total length of 255 mm in one direction and 127 mm in the other direction was tested. The results can also be affected by sample preparation and by natural variations of the material.

*Optical fluorescent microscope* Zeiss Axio Imager A1 was used for counting open cracks (Fig. 6B). Thin sections of approx. 20 mm x 35 mm were prepared with addition of a fluorescent substance. Methodology adopted was based on the one used in the Swedish Cement and Concrete Research Institute CBI for crack frequency. The methodology aims to distinguish material that might suffer weathering from those who might not suffer. The methodology consisted of the count of vertical and horizontal cracks on the thin section along a line of 100 mm in each direction along an imaginary grid. Results are expressed as cracks/mm, and 40x magnification was used. The procedure also evaluate the presence of intergranular cracks

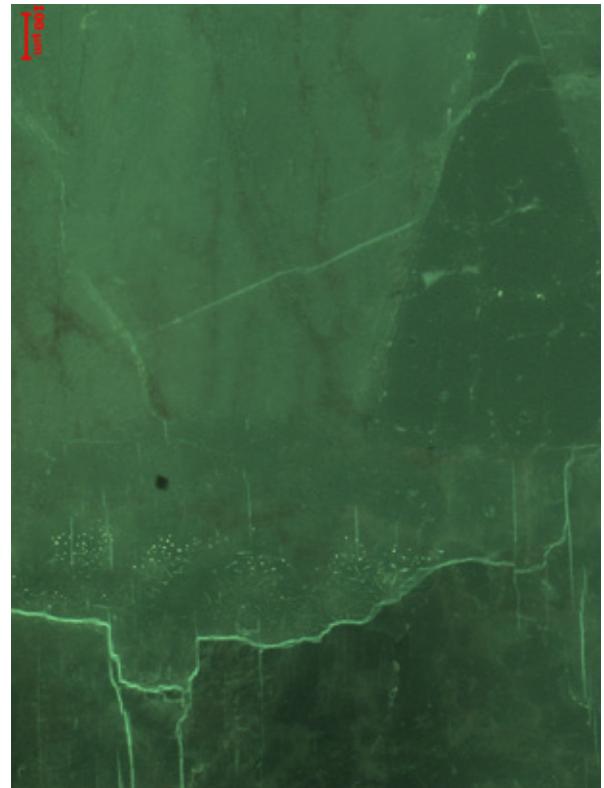
**Figure 17.** Image from the analysis performed at the fluorescent microscope (40x magnification).

Analysis performed with the fluorescent microscope (Fig. 17) was an easy and fast method for counting the cracks. The fluorescent substance brings in evidence the fractures. Studying of the images was immediate and the test was performed without the support of the computer.
